Contract #: 04-0120F4Cty: SF/ALA Rte: 80 PM: 13.2/13.9File #: 69.28**WELDING INSPECTION REPORT****Resident Engineer:**Siegenthaler, Peter**Address:** 333 Burma Road**City:** Oakland, CA 94607**Report No:** WIR-023170**Date Inspected:** 02-May-2011**Project Name:** SAS Superstructure**OSM Arrival Time:** 700**Prime Contractor:** American Bridge/Fluor Enterprises, a JV**OSM Departure Time:** 1900**Contractor:** Zhenhua Port Machinery Company, Ltd (ZPMC), Changxing Island **Location:** Shanghai, China

CWI Name:	N/A	CWI Present:	Yes	No			
Inspected CWI report:	Yes	No	N/A	Rod Oven in Use:	Yes	No	N/A
Electrode to specification:	Yes	No	N/A	Weld Procedures Followed:	Yes	No	N/A
Qualified Welders:	Yes	No	N/A	Verified Joint Fit-up:	Yes	No	N/A
Approved Drawings:	Yes	No	N/A	Approved WPS:	Yes	No	N/A
				Delayed / Cancelled:	Yes	No	N/A
Bridge No:	34-0006	Component:	OBG Trial Assembly

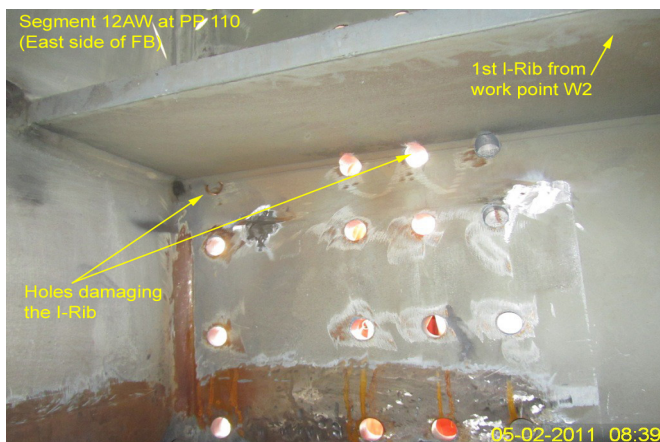
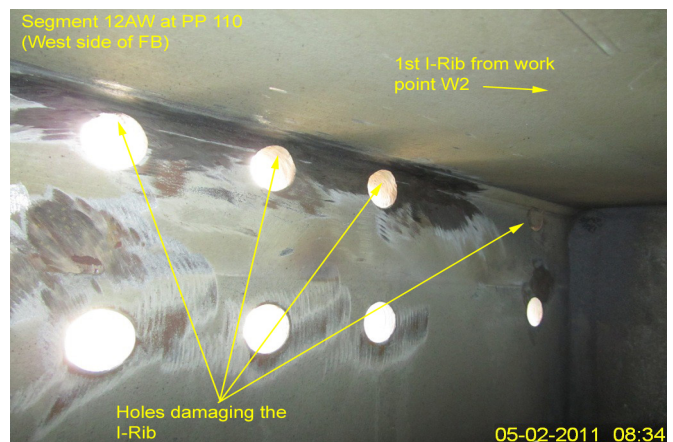
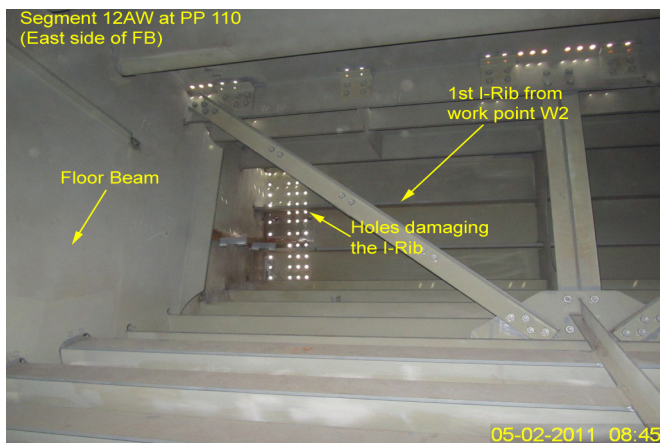
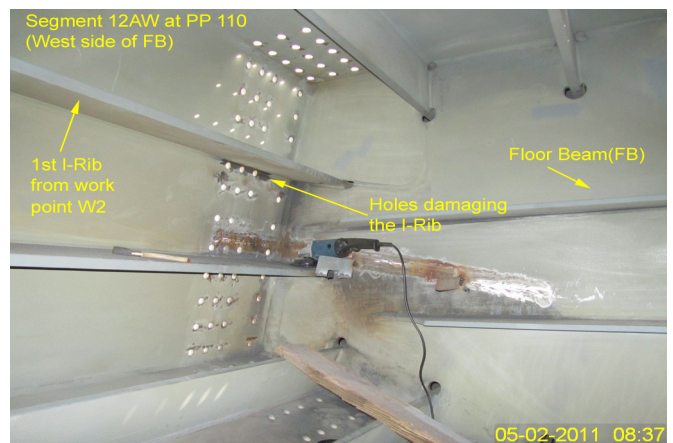
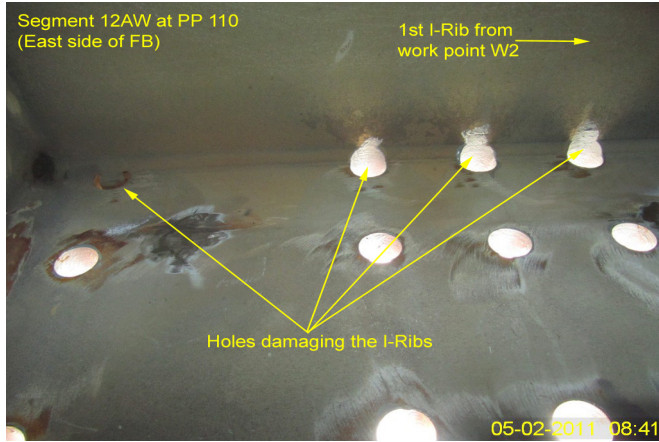
Incident Report generated at Segment 12AW (Edge Panel I-Rib)

This Quality Assurance (QA) Inspector wrote an Incident Report for mis-drilling the Edge Panel I-Ribs and damaging the fillet weld and I-Rib base material at PP 110 for Segment 12AW, Counter Weight side. Please reference the Incident Report # 04-0120F4_TL-15_B278_05-02-2011_Edge Panel_I-Rib_Mis-Drilled dated May 02, 2011 for further detail.

Please reference the pictures attached for more comprehensive details.
